SERVICE INSTRUCTION MANUAL

STANDARD CARS

STANDARD MOTOR COMPANY, LIMITED
CANLEY WORKS - - - COVENTRY

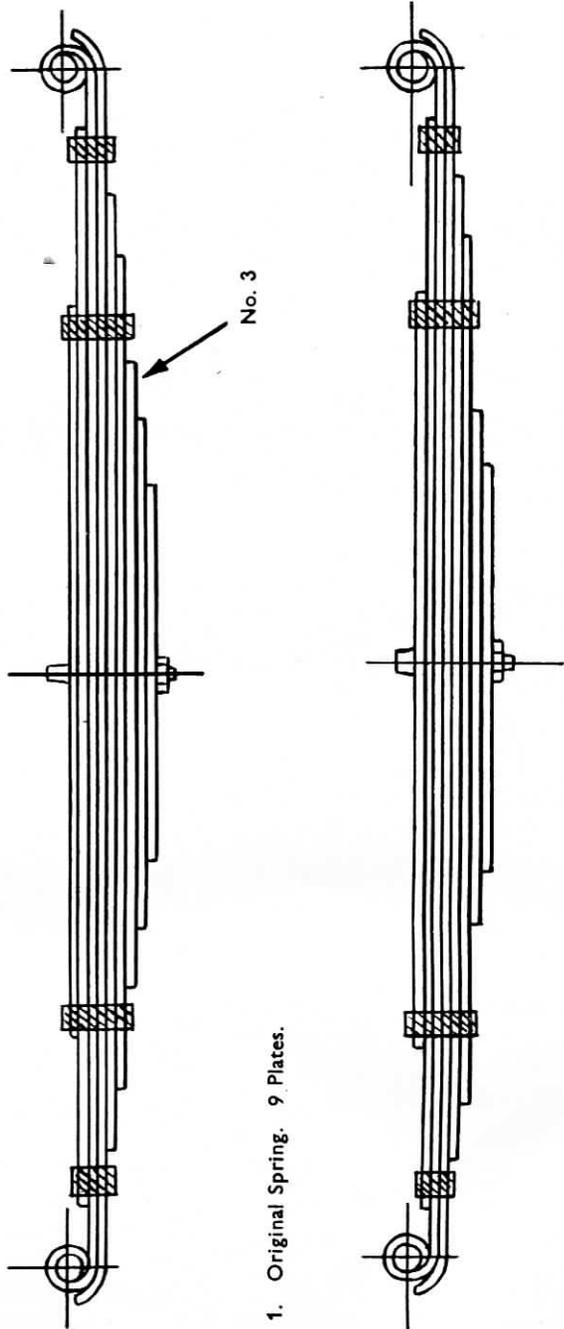
MODIFICATIONS TO R 12 H.P. REAR SPRINGS.

experienced on some machines through contact between the frame and axle. To remedy this, it has been found necessary to increase the clearance between the axle and frame by the following modification to the rear road springs—Remove the bottom spring leaf from each rear spring and place it on top of the spring with the camber the reverse way. It is not necessary to remove the springs in question, as the operation of carrying out the modification is as follows:—jack up chassis frame, remove rear wheel and loosen “U” bolts. It will then be necessary for the rear axle to be jacked up to give sufficient clearance between the top leaf of the rear spring and the axle. A cramp will be required to keep the leaves from springing apart.

The bottom leaf should then be placed on top of the top spring with the camber reversed, then the centre bolt should be refitted.
